OBERHEIM ELECTRONICS, INC.
ENGINEERING CHANGE ORDER

OB-8

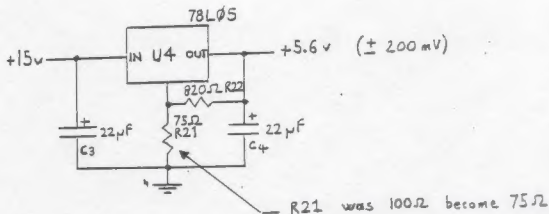
Reduce output of 5.6v Supply.

Increase the active range of the Front panel pots

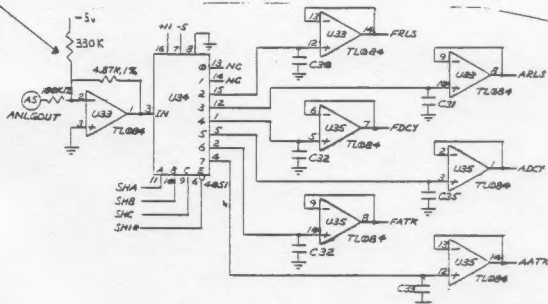
Add a resistor between -5v and pin 2 of U33 (upper & lower voice)
A software revision A-4 or posterior must be installed and the offset
calibration of the service center test must be performed.

The offset calibration routine of the service center test can correct
the TL084 for positive or negative offset.

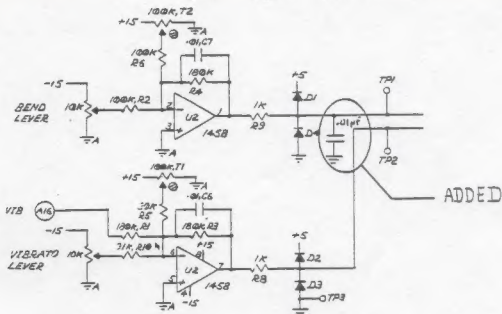
OB-8 BEND BOX 1680A SHEET 1 OF 1

- REMOVES NOISE MODULATION FROM BENDER LEVER

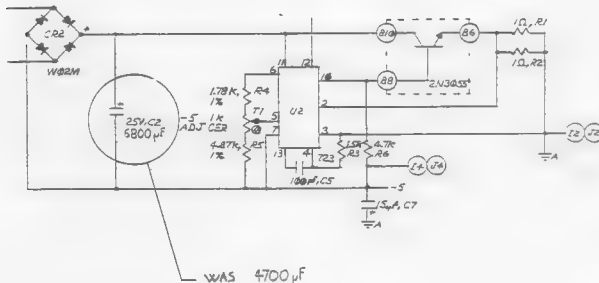
PROCESSOR BOARD- POWER SUPPLY
1679A SHEET 4 of 4

WHEN THE NEW POWER SUPPLY TRANSFORMER (REF.561021) IS USED, THIS CHANGE DECREASES THE OUTPUT THUMP ON POWER OFF.

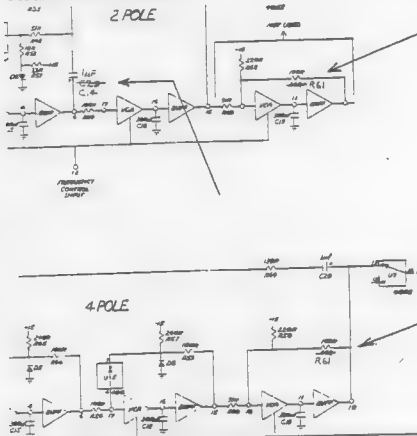
RESISTOR AT UX06 PINS 10, 18 MARKED RX68 SHOULD BE RX61.

CAPACITOR IN 2 POLE/4 POLE CONFIGURATION DRAWING MARKED C20 SHOULD BE C14.

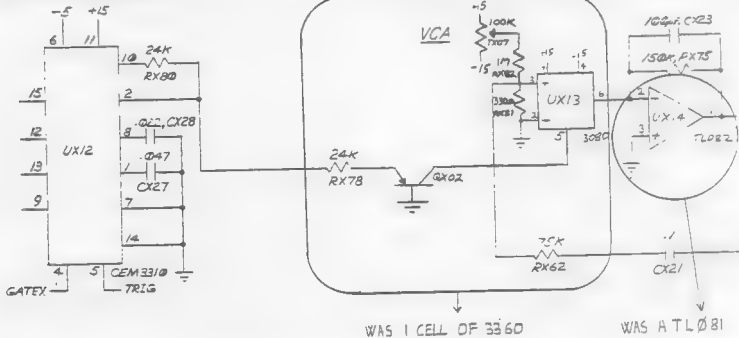
OB-8 VOICE BOARD 1632 B SHEET 3 of 3

— ALSO: UX08 IS DELETED AND REPLACED BY THE OTHER CELL OF THE 74182 UX14

— RATIONALIZE THE CIRCUITRY

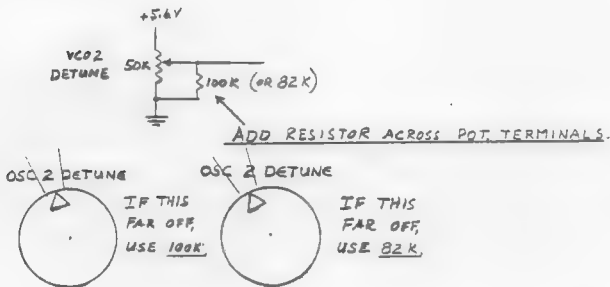
1681 B

TO CENTER OSC 2 DETUNE CONTROL WHEN LED GOES OFF
WITH KNOB SIGNIFICANTLY COUNTERCLOCKWISE OF CENTER.

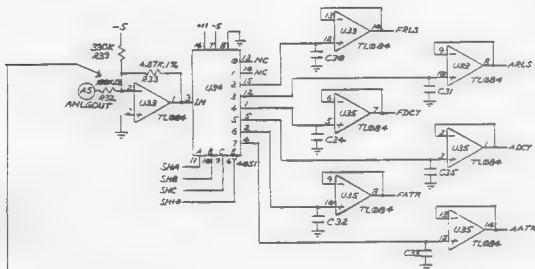
OB-8 VOICE BOARD 1682B SHEET 2

R32 100K 1% are 50 Ω matched between Lower and upper Tray.

R32 on the Lower and upper tray are mounted after the two boards are screwed together.

—IMPROVES MATCHING OF TIMING BETWEEN ENVELOPES OF UPPER AND LOWER TRAY.

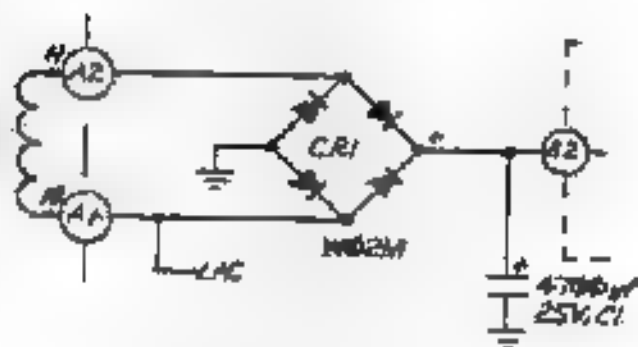
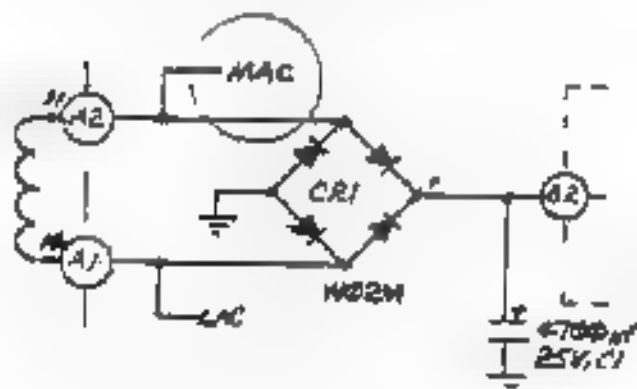
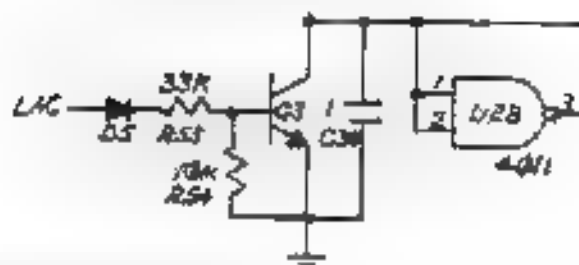
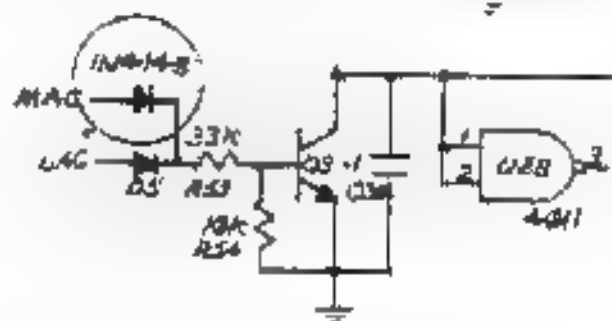
IMPROVE MARGIN OF "PVP" CIRCUIT TO INADVERTENT TURN-OFF, ESPECIALLY AT 50 Hz.

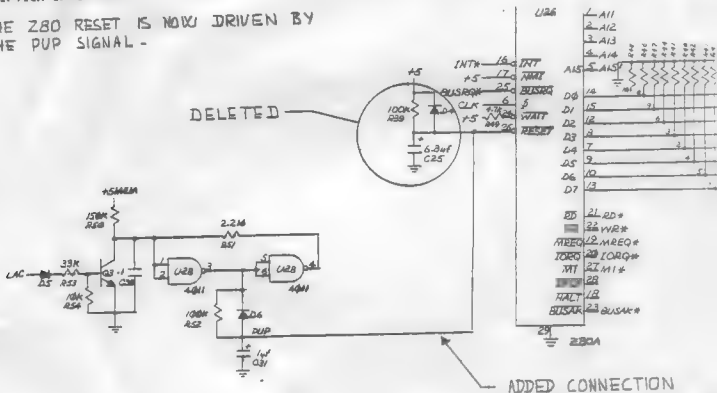
PROCESSOR BOARD 1679B SHEET 1 OF 4

THE Z80 RESET IS NOW DRIVEN BY
THE PUP SIGNAL -

TO AVOID POSSIBLE MEMORY DROP CAUSED BY SHORT POWER DROP

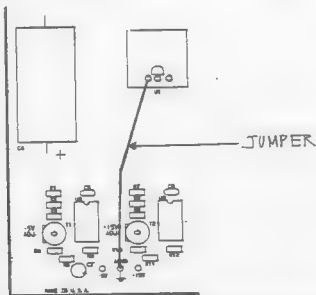
ADD A JUMPER BETWEEN PIN 1 OF THE -15 REGULATOR
7915 (GND) AND THE GROUND REFERENCE TEST POINT.
THE JUMPER MUST BE MADE OF A 18 AWG WIRE (.04 inch / 1 mm)
MINIMUM AND MUST BE SHORT.

TO REMOVE AC HUM ON AUDIO OUTPUT.

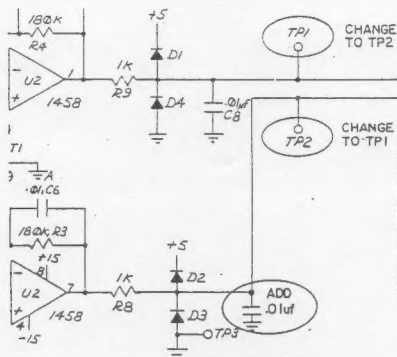
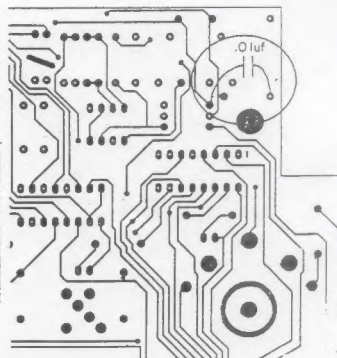
1. CHANGE SCHEMATIC AS SHOWN.
2. ADD .01uF CAP (OB.153004) FROM GROUND TO TEST POINT (T.P. 2) OF MOD CAN PCB ON 1666 SIDE OF BOARD.

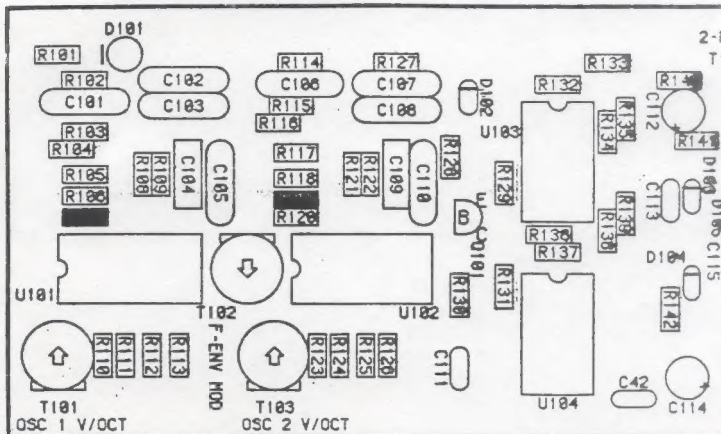
REPLACE RESISTOR RX07 AND RX19 (215K, 1%)
WITH 174K, 1% (OB#475520).

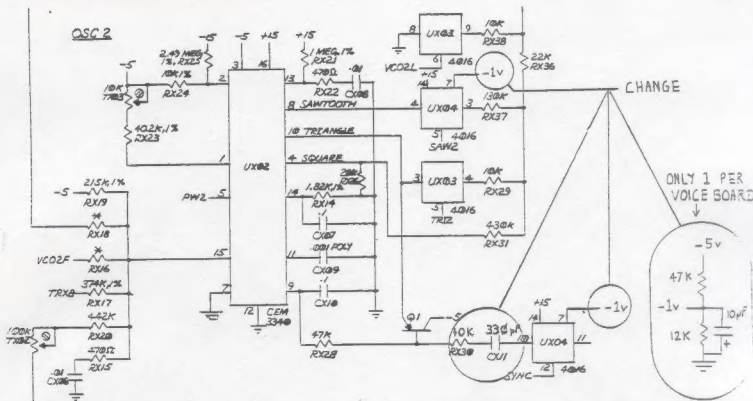
OB-8 VOICE BOARD 1682 A SHEET 30F2

- IMPROVES SYNCHRO SOUND
